Maryland Inventory of Historic Properties number: R Name: S / Southwestern	30-2781 Blod.) over CSX 1
The bridge referenced herein was inventoried by the Mary Historic Bridge Inventory, and SHA provided the Trust w The Trust accepted the Historic Bridge Inventory on April determination of eligibility.	rith eligibility determinations in February 2001
MARYLAND HISTO	RICAL TRUST
Eligibility Recommended	Eligibility Not RecommendedX
Criteria:AB CD Considerations: _ Comments:	ABCDEFGNone
Reviewer, OPS: Anne E. Bruder	Date: 3 April 2001

MARYLAND INVENTORY OF HISTORIC BRIDGES HISTORIC BRIDGE INVENTORY MARYLAND STATE HIGHWAY ADMINISTRATION/MARYLAND HISTORICAL TRUST

SHA Bridge No. 3008 Bridge name US 1 over CSX Transport Railroad
LOCATION: Street/Road name and number [facility carried] US 1 (Southwestern Boulevard)
City/town Halethorpe Vicinity X
County Baltimore
This bridge projects over: Road Railway_X Water Land
Ownership: State X County Municipal Other
HISTORIC STATUS: Is the bridge located within a designated historic district? Yes NoX
Name of district
BRIDGE TYPE: Timber Bridge: Beam Bridge: Truss -Covered Trestle Timber-And-Concrete
Metal Truss Bridge
Movable Bridge: Swing Bascule Si

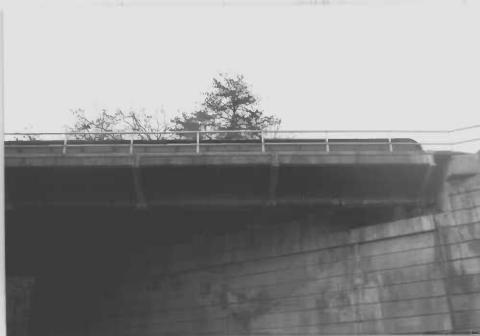
1. BA - 2781 2. US I OVER CSXT RR 3. BALLMORE County 4 Eric Griffitts 5.3/97 6 MD SHPO 7. detail of added concrete sidewalk 8-6016

The sidewalk was added to the structure at an unknown date. Inspection reports from 1996 mention repairs to the floorbeams, but do not specify the nature of the repairs.
